SHELTER PERFORMANCE STANDARD ASSESSMENT REPORT 2023

Rohingya Refugee Response, Cox's Bazar, Bangladesh

Data Collection: February – April 2023

**SHELTER & CCCM
SECTOR**
Cox's Bazar, Bangladesh

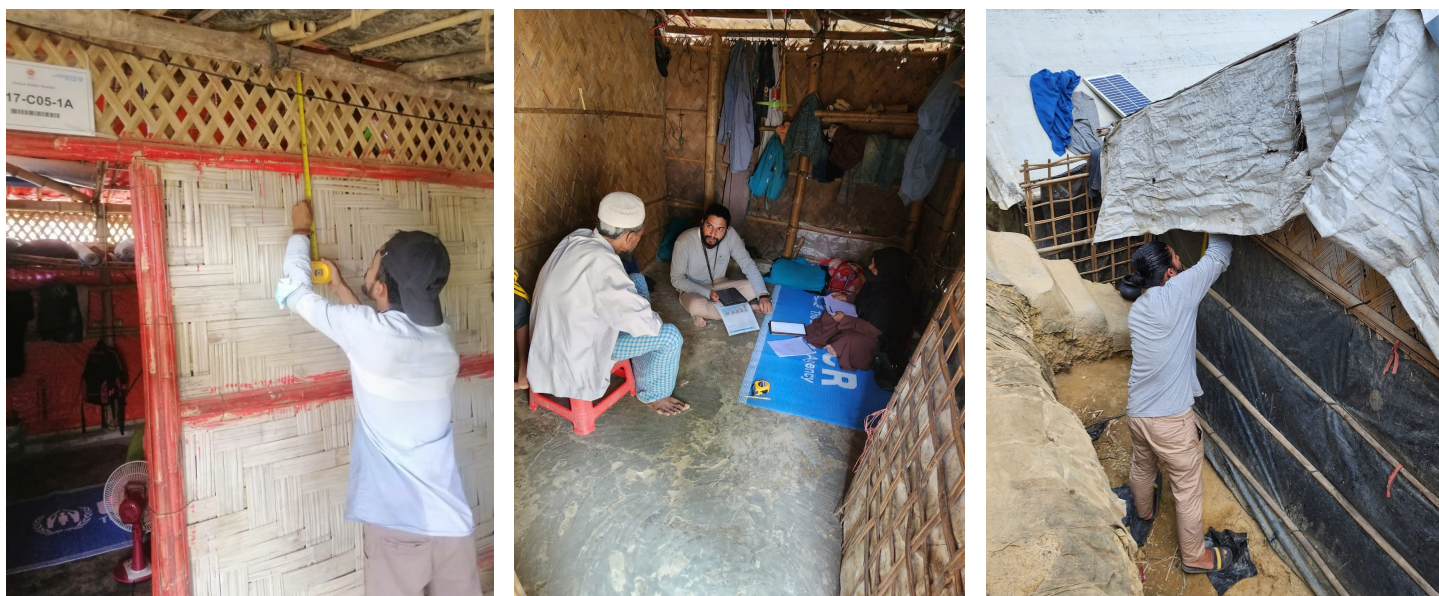
Image: NPM Enumerators were Assessing Shelters During the Study: (From left to right) the First Image Demonstrates an Enumerator Measuring Garenja Height (Camp 17), the Second Image Shows a Male Enumerator Interviewing a Male Respondent alongside a female enumerator entering information into Kobo (Camp 18), and the third Image Illustrate an Enumerator Measuring Tarpaulin Covering the Wall (Camp 18).

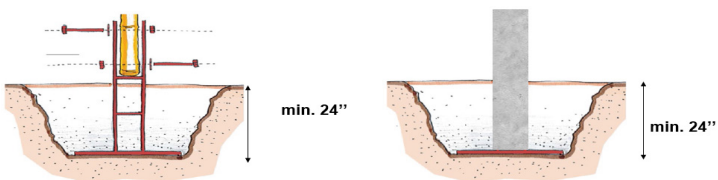
Left: Metal footing 2' under the ground; Right: concrete post 2' under the ground

(Graph 11) 43% of shelters had less than 4 metal footings installed 24 inches in the ground, while 39% of shelters had 4 to 9 metal footings and 12% had 10 to 15 metal footings and 6% had above 15 metal/concrete footings 24 inches in the ground.

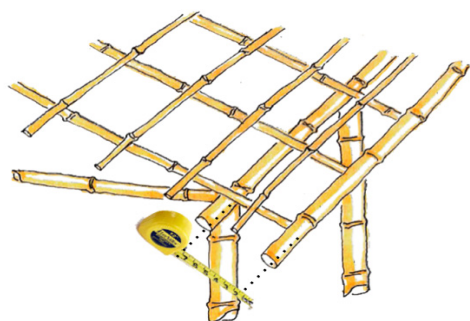
Distance between purlins

max distance between purlins 12"

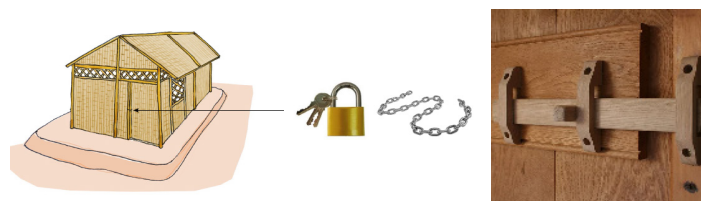
Image: Shelter is lockable from inside and outside using padlock and chain

Image: If only inside latch then partially locked

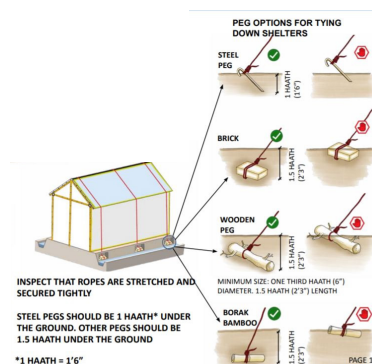
Types of Pegs

Tying the shelter to the metal footing
