SHELTER PERFORMANCE STANDARD ASSESSMENT REPORT 2024

Rohingya Refugee Response, Cox's Bazar, Bangladesh

Data Collection: April – June 2024

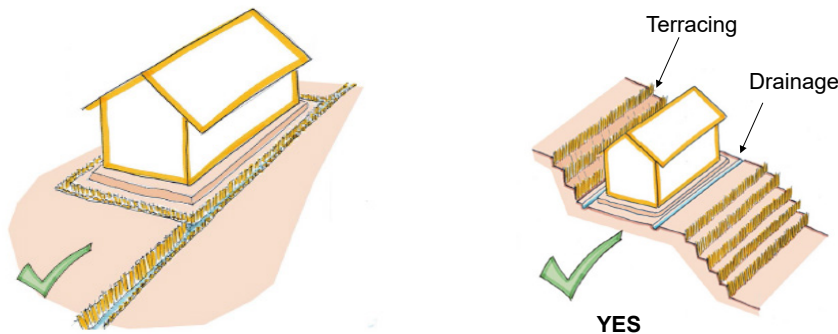
Image 5: Shelters with adequate drainage

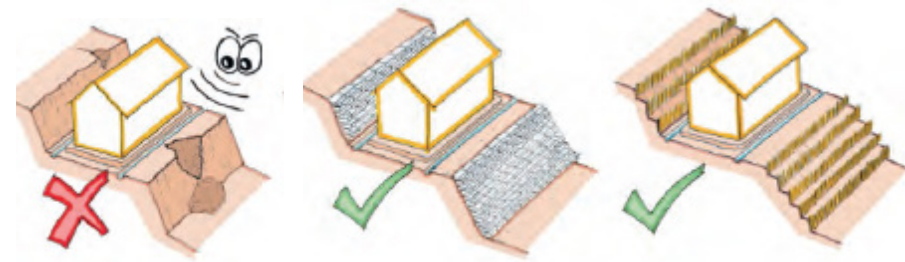
Camp 4 Ext (99%) had the highest proportion of shelters located on safe sites and Camp 8W (38%) had the lowest proportion of shelters located on safe sites.

Image 7: Site safety of shelters

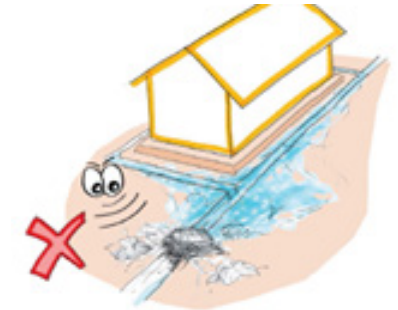
Image 10: Standing water in the surrounding area of the shelter that creates water logging

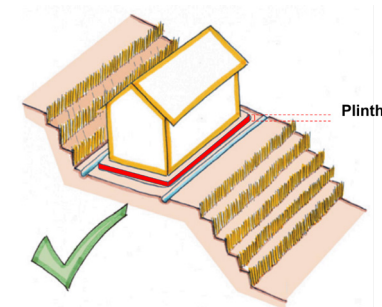
46% of the shelter were observed to be standing on a plinth with minimum height of 15cm (6") and 53% were not (graph 14). Camp 4Ext and NRC had the highest percentage (77%) and Camp 21 (11%) had the lowest percentage of shelters standing on a plinth.

Image 11: Shelter standing on a plinth

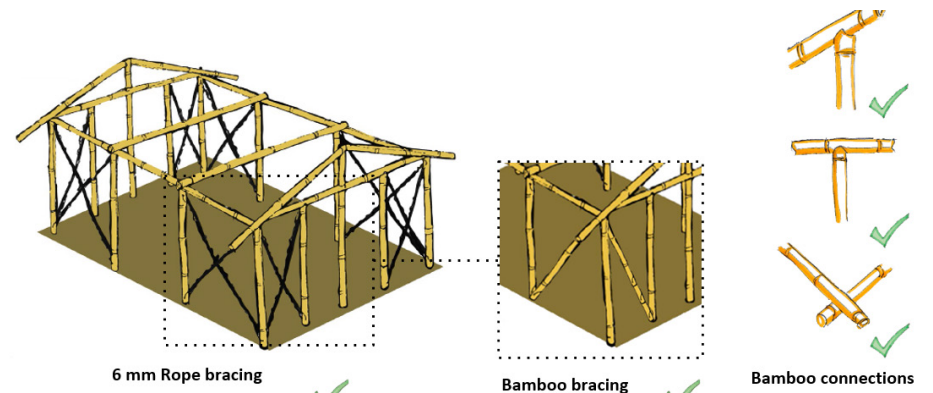
14% of of shelters met the minimum standard fully or partially for having adequate bracing in all corner bays of the shelter or at least having bracing at three corners. 86% of shelters did not meet the standard, with less than three corners having adequate bracing (graph 21).

Image 16: Different types of bracing

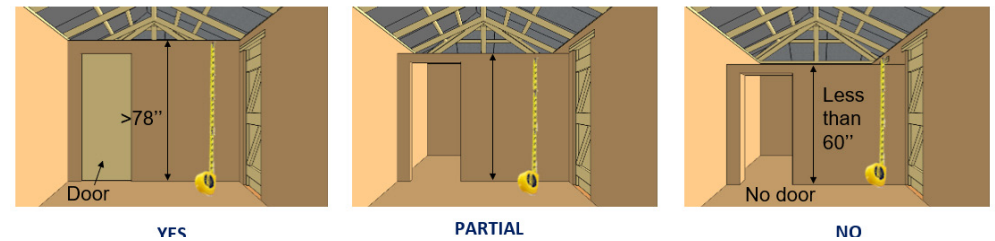
96% of shelters fully and partly had at least one internal partition wall to provide privacy (at least 78" partition with door, or if partition is equal to or more than 78" but without a door, or if the partition is between 60" and 78" with or without door). 4% of shelters did not meet the standard (if there is no partition or if the partition is less than 60" with or without door (graph 23)).

Image 17: Having at least one partition wall to provide privacy

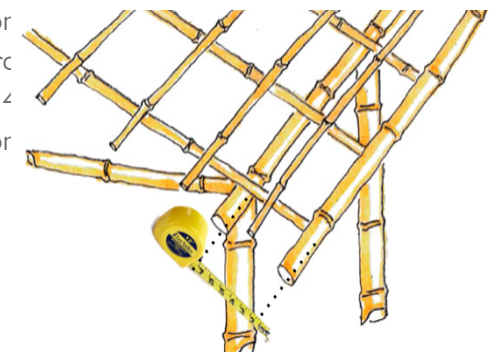
Image 25: Distance between bamboo purlins

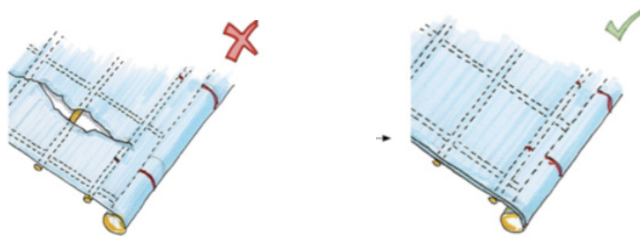
16% of the households reported rainwater not entering through tarpaulin on the roof while 84% stating it entered through the roof (n= 1,811). Of those reporting roof leaks (n=1,515), 96% had 1-4 leakage points, while 4% had 5 or more (graph 37).

Image 26: Roof of the shelter with and without leakage points

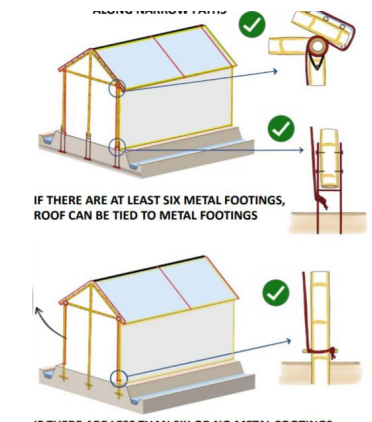
Image 33: Tying the shelter to the metal footing

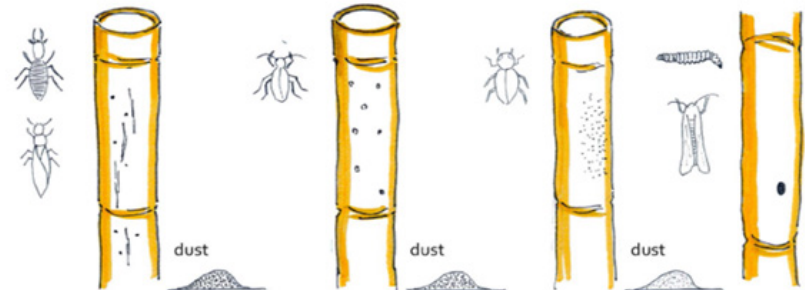
Image 37: Signs of bamboo infestation: big holes, a group of small holes and/or bamboo dust

51% of households reported signs of infestation in 5 to 8 bamboo poles, followed by 24% who indicated infestation in 9 to 12 bamboo poles. Additionally, 15% of households observed infestation in 1 to 4 bamboo, while 10% reported infestation in 13 or more bamboo (graph 45).

The signs of infestation observed were small holes (37%), dust (31%), and big holes (31%).
