Report

Biofil Toilet Evaluation

Rohingya Refugee Camp, Cox's Bazar, Bangladesh

February 2020

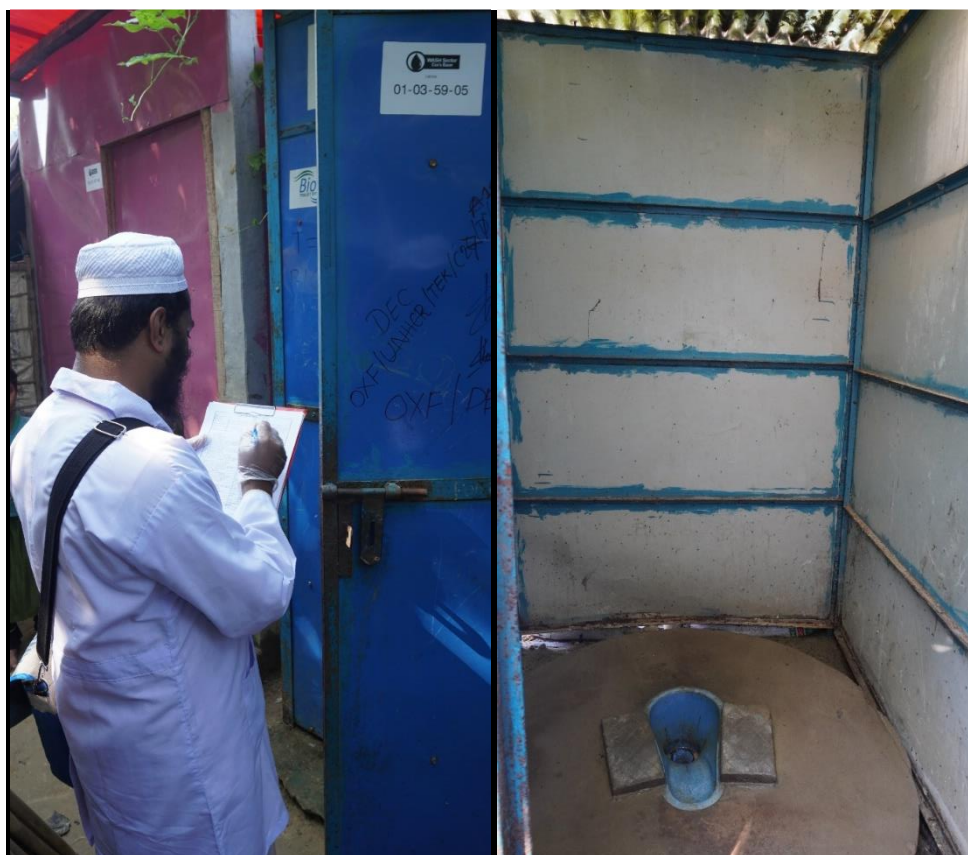
Photograph 2.1: Oxfam constructed 48” dia Biofil toilet at Camp-27, Teknaf Nayapara Camp (ID: Taknaf-Camp 27-SL7-ID-104)

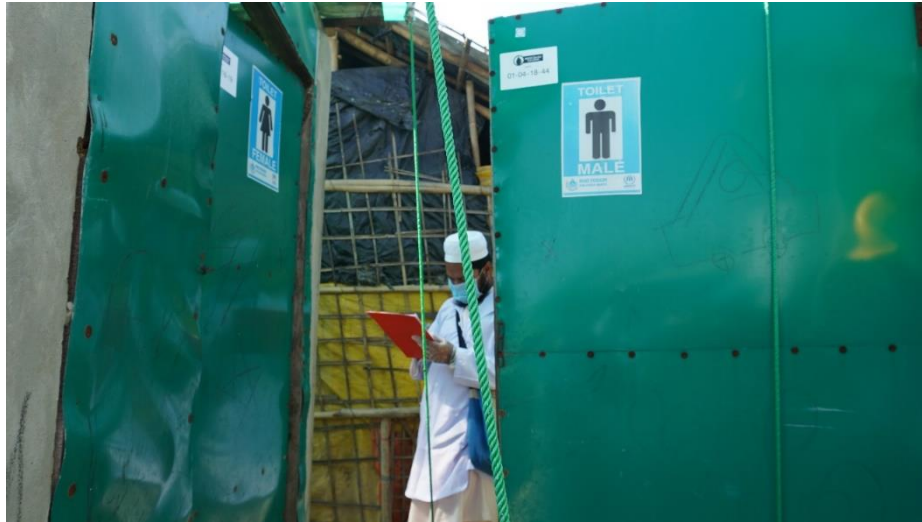
Photograph 2.2: NGO-Forum constructed 48” dia Twin pit pour flush latrine at Camp-26, Teknaf Nayapara Camp [ID: Teknaf-Camp26(A)-SL10 –ID-42]

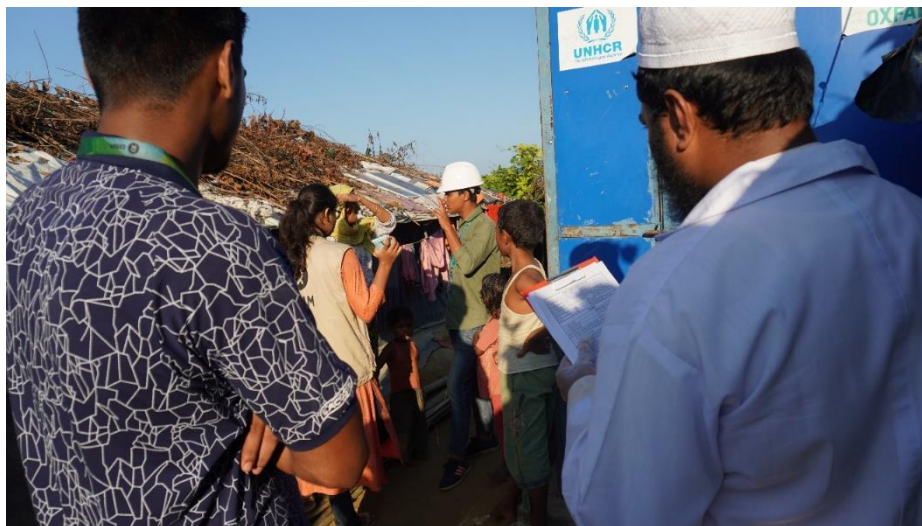
Photograph 2.3: Oxfam constructed 48” dia Biofil toilet at Camp-27, Teknaf Nayapara Camp [ID: Teknaf-Camp27(B)-SL4-ID-69]

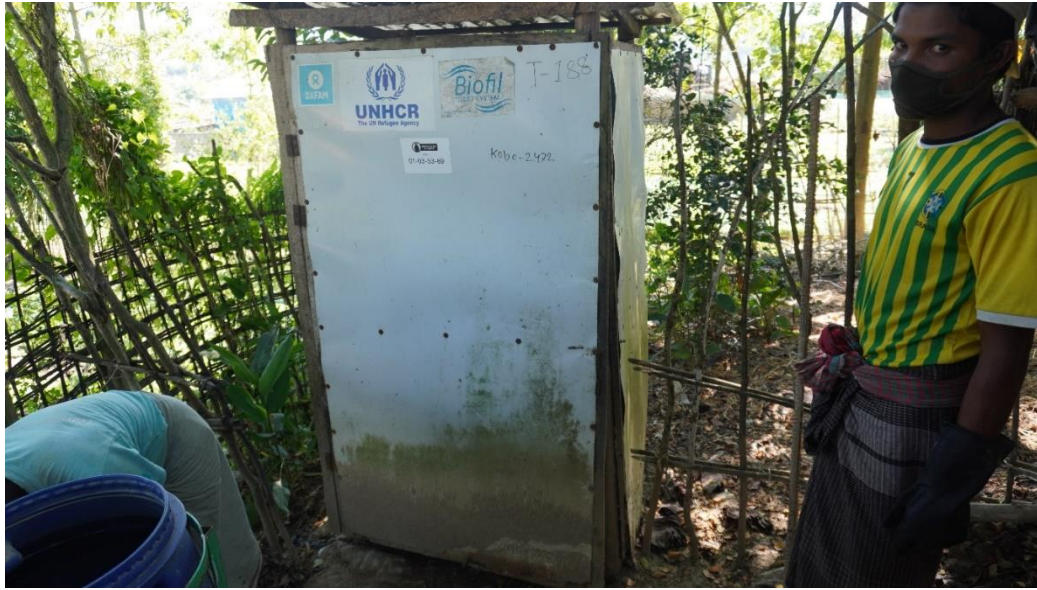
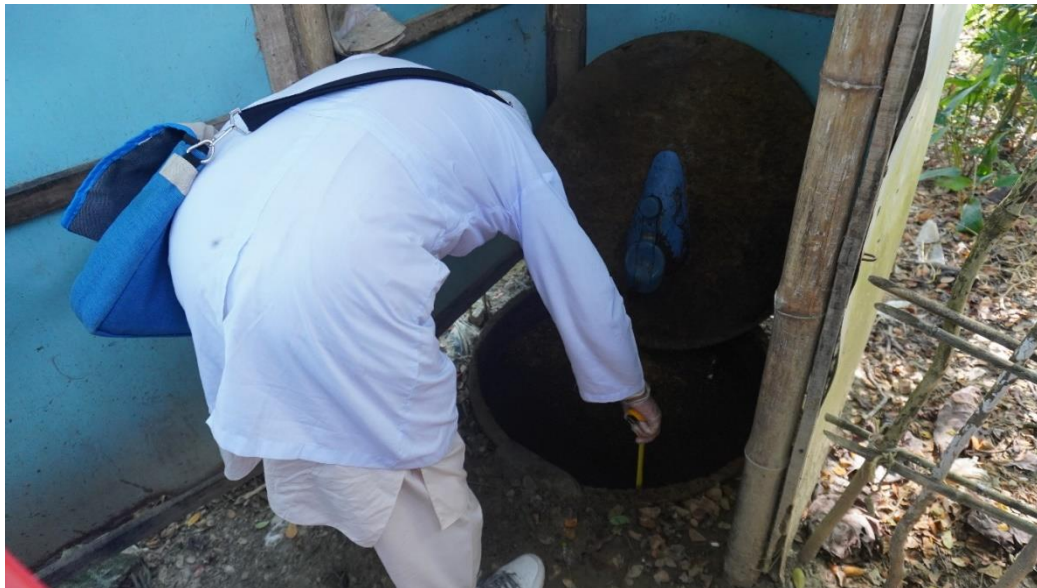
Photograph 2.4: Oxfam constructed 36" dia Biofil toilet at host community adjacent to Camp-22, Teknaf Whykong Camp [ID: Teknaf-Camp22(Host)-SL1-HH-ID-1120]

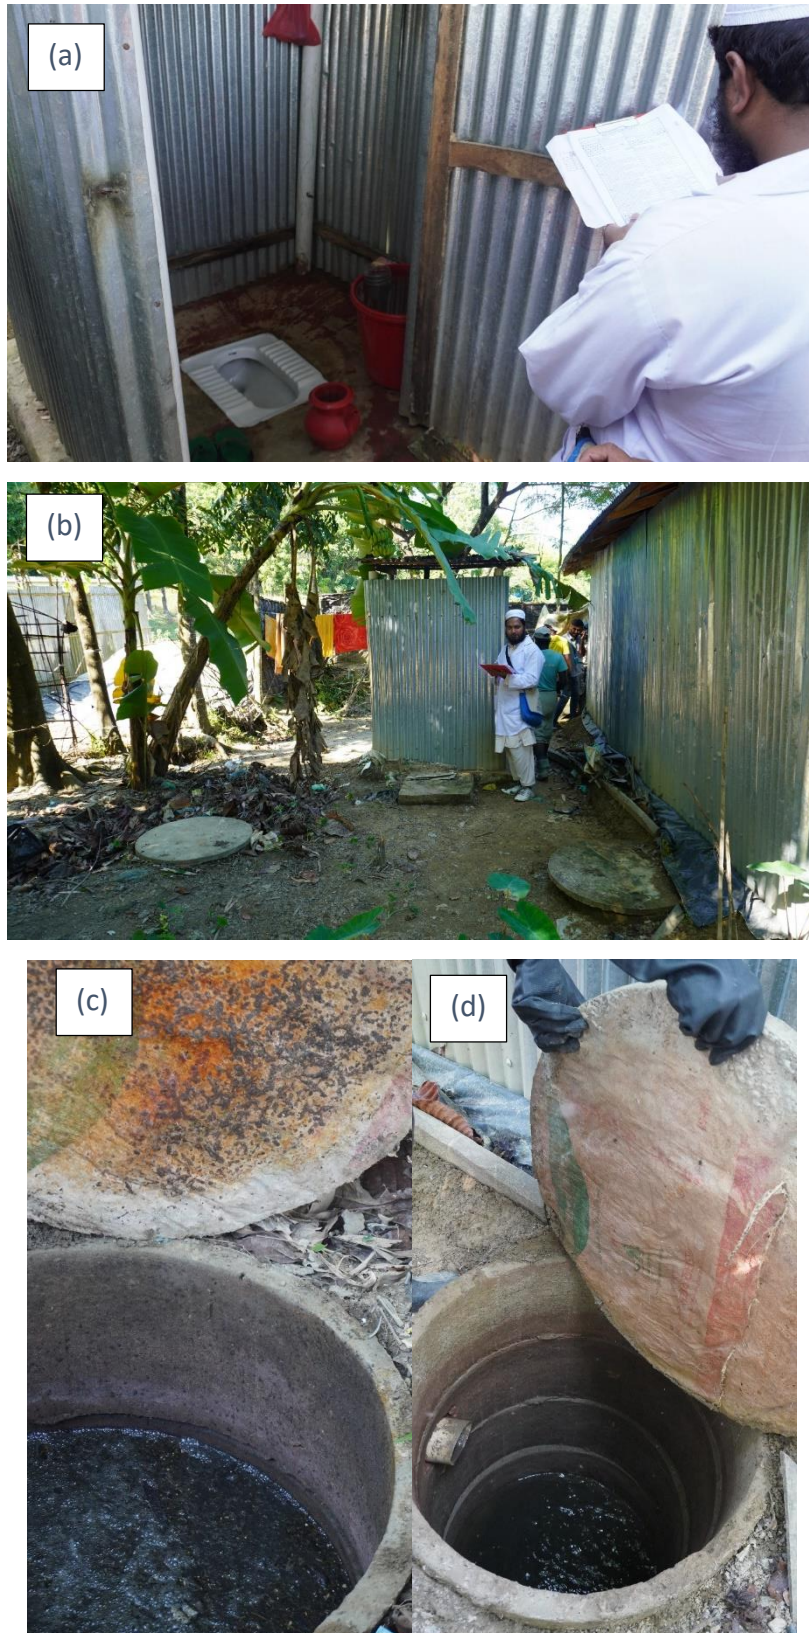
Photograph 2.5: BRAC constructed 2.5" dia alternative twin pit pour flush toilet at host community adjacent to Camp-22, Teknaf Whykong Camp (ID: Teknaf-Camp22 (Host)-SL6-HH-ID-1052) [(a): inside condition of alternative twin pit toilet, (b) backside view (c) used pit, & (d) pit not currently in rest]

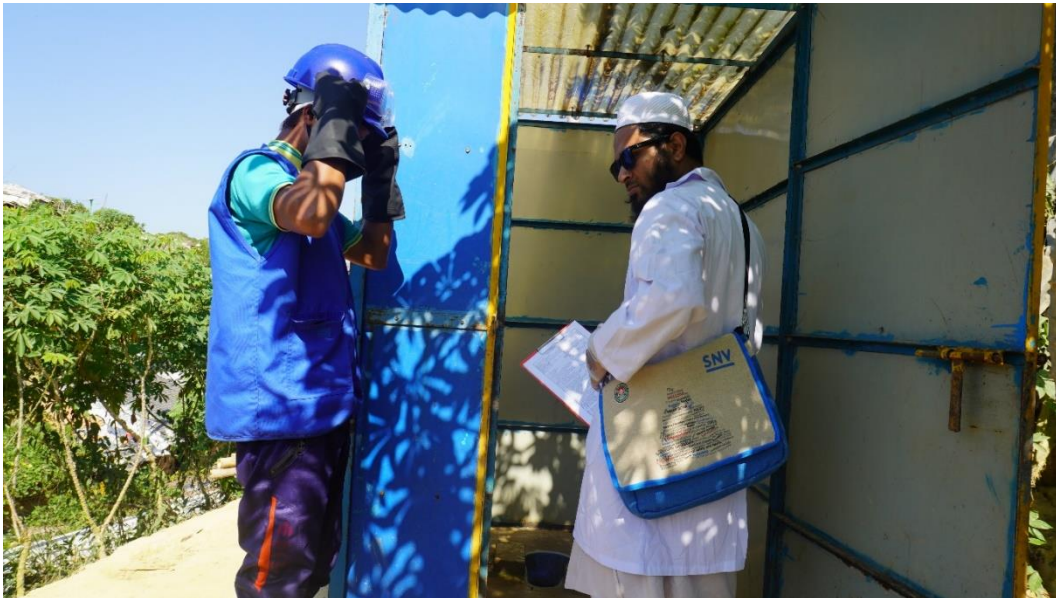
Photograph 2.6: Oxfam constructed Biofil toilet at Camp-12, Ukhia Balukhali Camp [ID: Ukhia-Camp12(B-4)-SL4]

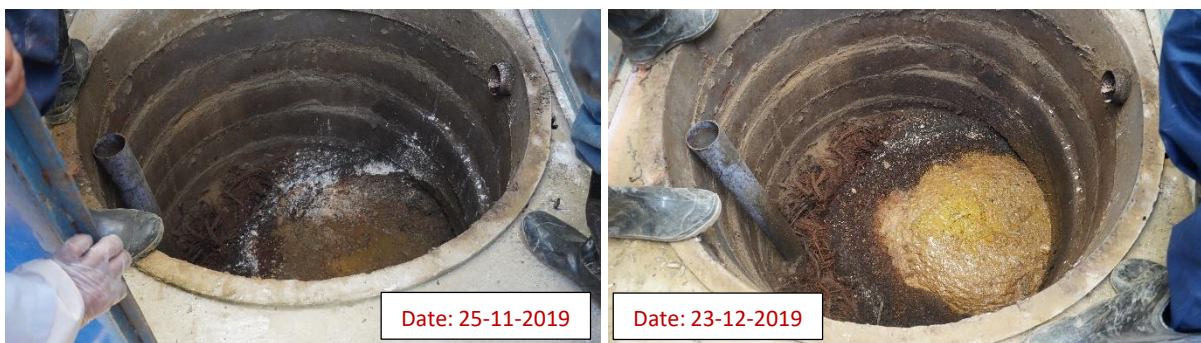
Photograph 2.7: Inside condition of digester of a Biofil toilet at Camp-27, Teknaf Nayapara Camp [ID: Teknaf-Camp 27(B)-SL4-ID-69]

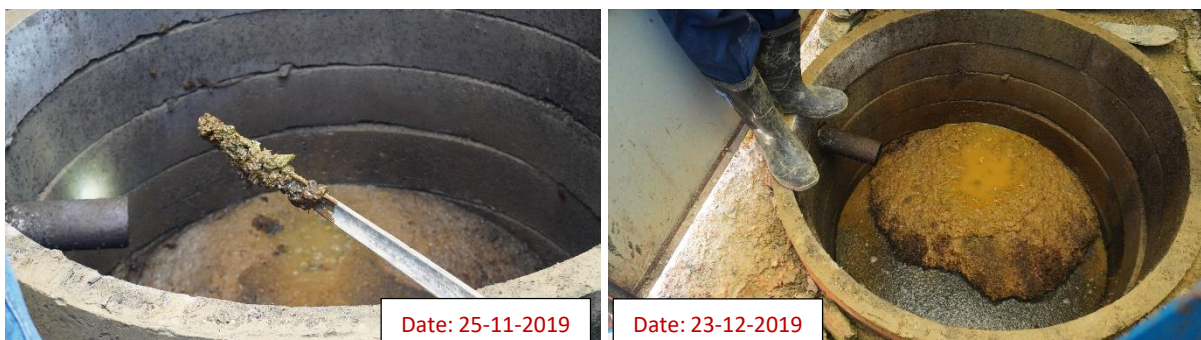
Photograph 2.8: Inside condition of digester of a Biofil toilet at Camp-27, Teknaf Nayapara Camp [ID: Teknaf-Camp 27(B)-SL2-ID-47]

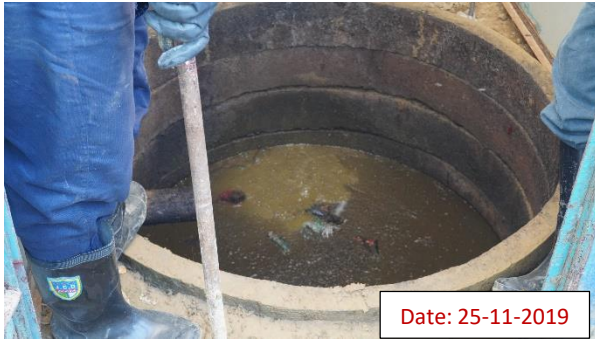
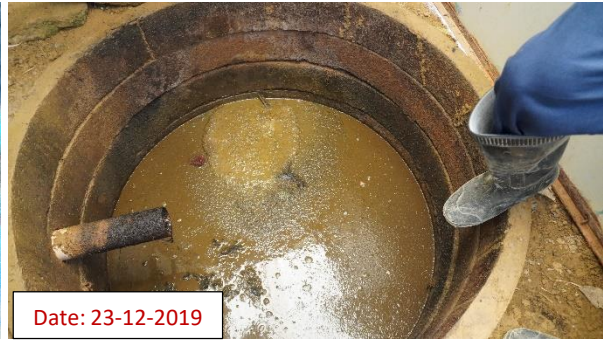
Photograph 2.9: Inside condition of digester of a Biofil toilet at Camp-27, Teknaf Nayapara Camp [ID: Teknaf-Camp 27(B)-SL3-ID-59]

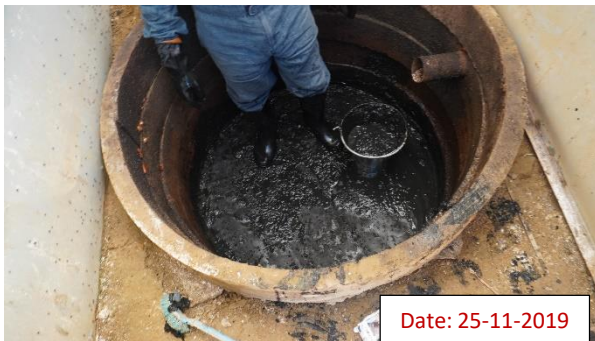
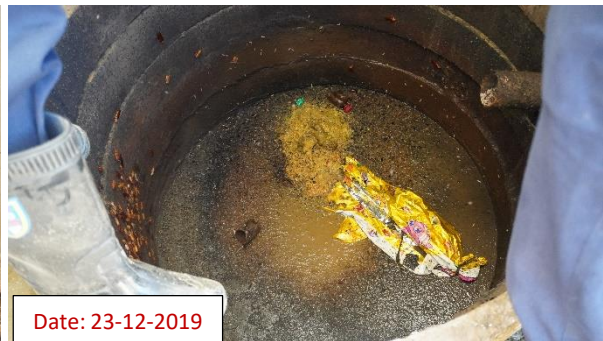
Photograph 2.10: Inside condition of digester of a Biofil toilet at Camp-26, Teknaf Nayapara camp [ID: Teknaf-Camp 26(C)-SL6-ID-147]

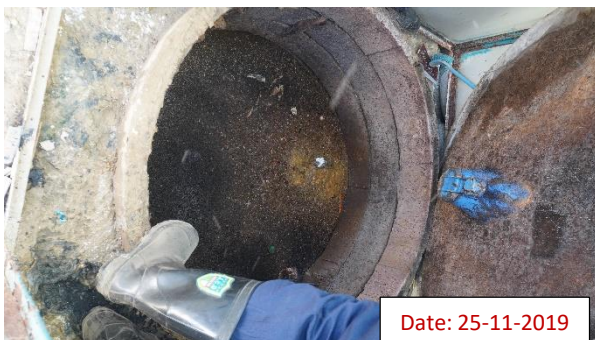
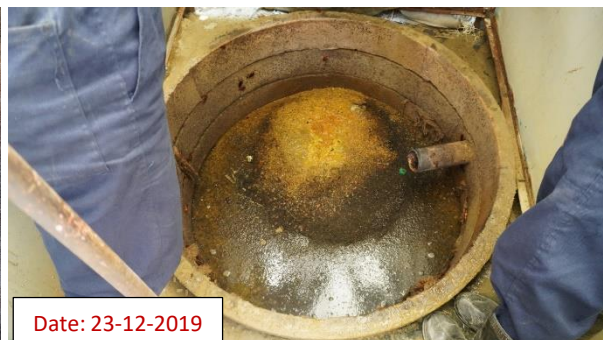
Photograph 2.11: Inside condition of digester of a Biofil toilet at Camp-26, Teknaf Nayapara Camp [ID: Teknaf-Camp 26(C)-SL5-ID-189]

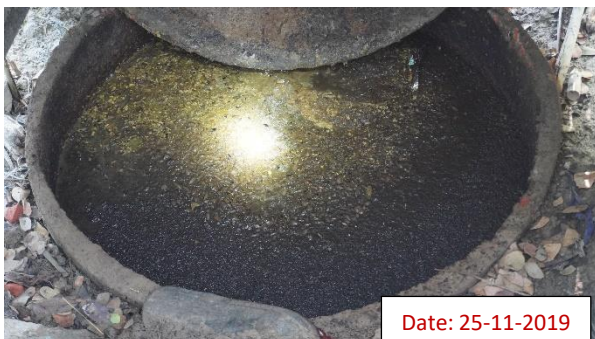
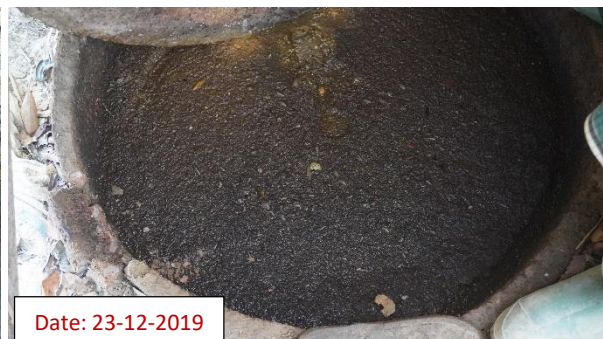
Photograph 2.12: Inside condition of digester of a Biofil toilet at host community near Unchirang Camp-22, Teknaf [ID: Teknaf-Camp 22(Host)-SL1-HH-ID-1120]

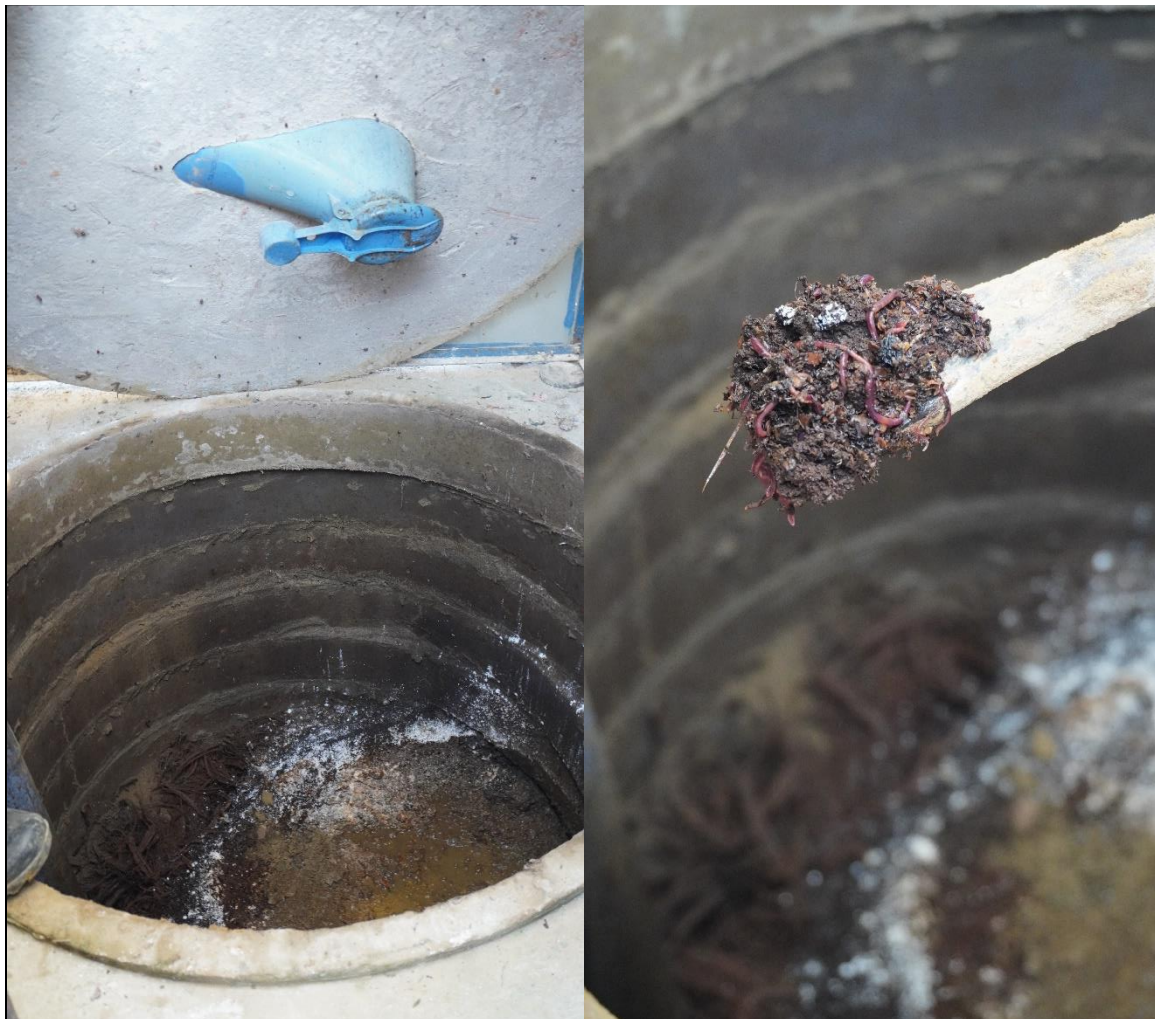
Photograph 2.13: Inside condition of digester of a Biofil toilet at Camp-27, Teknaf Nayapara Camp (ID: Teknaf-Camp 27(B)-SL4-ID-69) where Tiger worms were detected in the digester

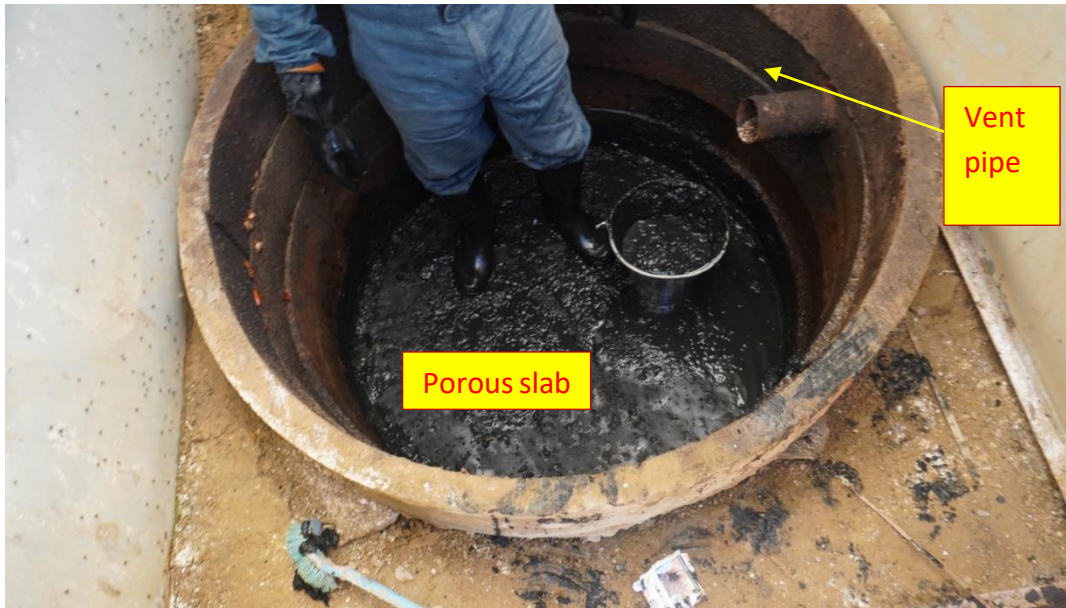
Figure 3.2: Positioning of vent pipe and porous slab for Type-1 Biofil toilet; photograph taken during desludging operation

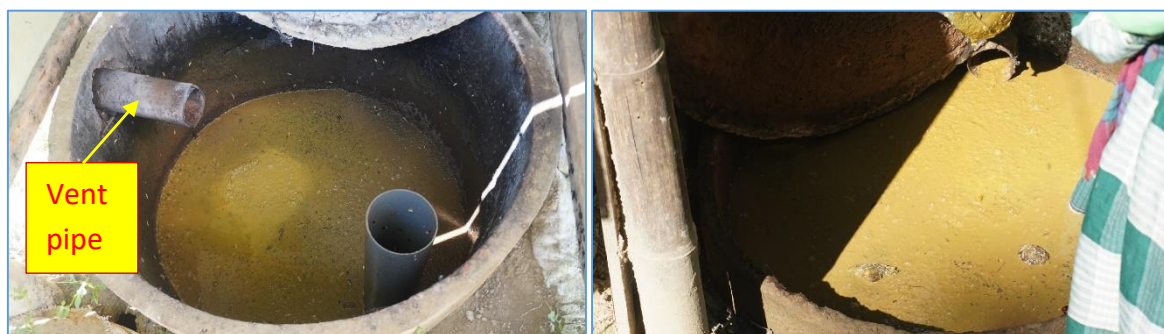
Figure 3.5 shows plan and sectional view of a Type-2 Biofil toilet. The floor area of the toilet is about 3'-6" x 3'-6". The roof is inclined with clear height of 5'-9" at front side and about 5'-3" at back side. Sato-pans have been used in all Biofil toilets. A 3-inch diameter vent pipe has been used for venting of foul gas from the pit (not shown in the figure). It was found that the bottom of the vent pipe has been inserted into the pit at a depth of about one foot or less. This appears to be causing a major problem; sludge continues to build-up in the digester with time and eventually reaches the bottom level of the vent pipe and clogs it. When this happens, the vent pipe is taken out from the pit.

Figure 3.5: Positioning of vent pipe for Type-2 Biofil toilet (a) & Sludge in digester builds-up to clog the vent pipe (b)

- (1) Most Biofil toilets (as well as regular pit latrines) satisfy the criteria of a “hygienic latrine”. A few Biofil toilets however failed to satisfy one criterion on venting of foul gas, because the users had to remove to vent pipe that was clogged (at the bottom) with accumulated sludge. This issue/problem could be addressed with design modification.

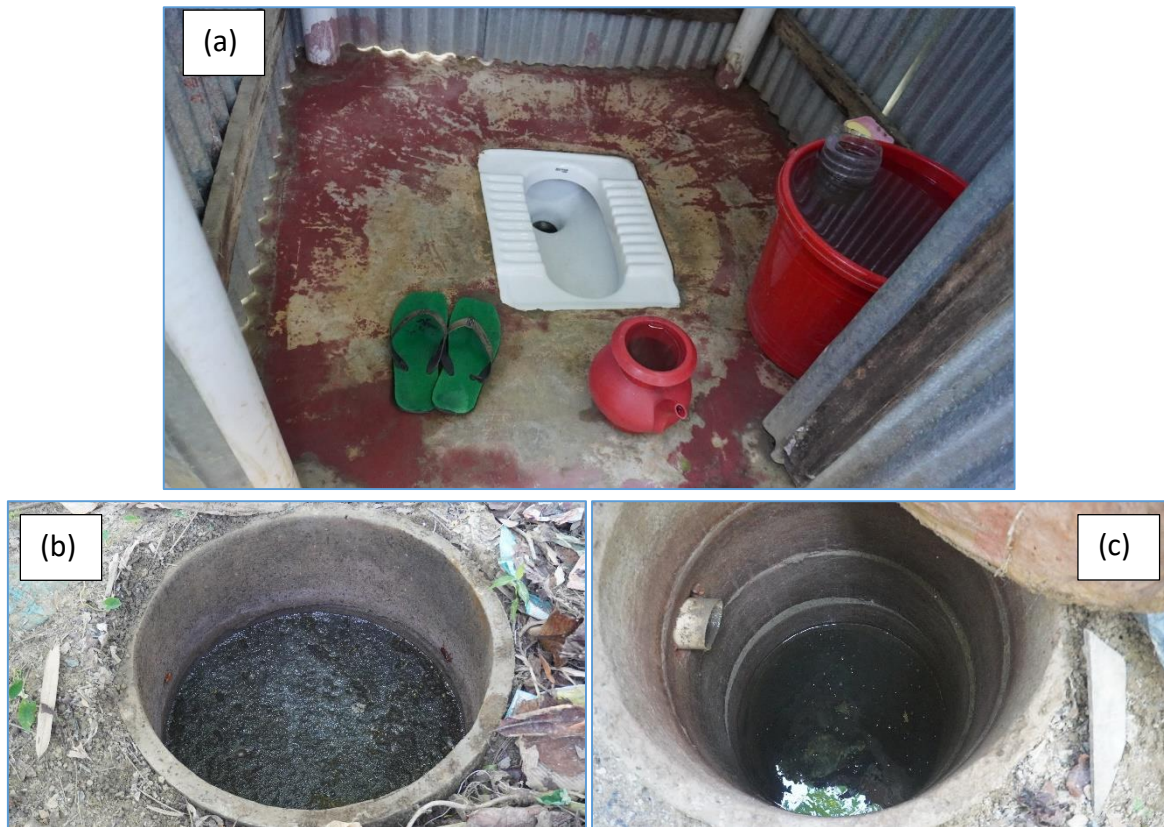
Floor area of these toilets is about 5' x 5' for each chamber. Superstructure is mostly made of CGI sheet, wood and bamboo. For the two toilets in Camp 26, the pits are made up of 4-foot diameter concrete rings, with a total depth of about 10 feet. While for the remaining toilets, pits are made of 2.5 feet diameter concrete rings with a total depth of about 6 feet (as shown in Figure 3.8).

Figure 3.8: Inside view of alternative twin-pit latrines with 2.5 ft diameter concrete rings (a); [(b) operational pit, (c) pit in rest]

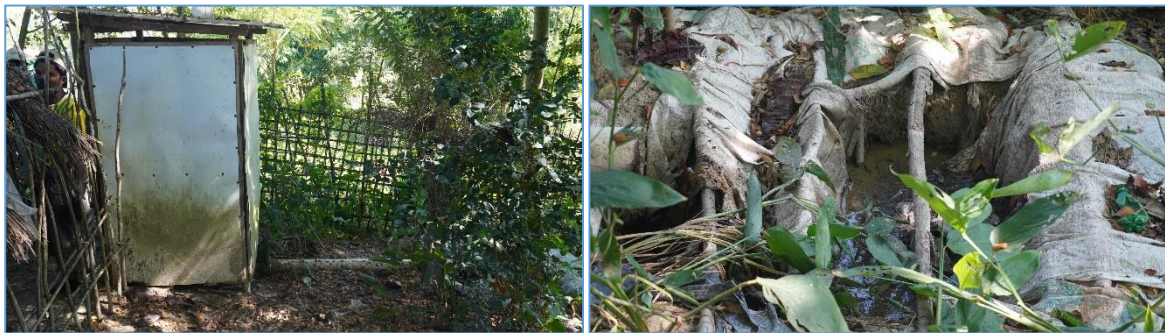
The third criterion is the presence of vent pipe for venting of foul gas from the pit/digester. Among the Biofil toilets surveyed, all except one [ID: Teknaf-Camp22(Host)-SL1-HH-ID-1120] had vent pipes. The vent pipe for this unit is being used as pipe to discharge fecal sludge from digester to nearby (as shown in Figure 3.9). During field visit, foul smell was detected in this toilet (see Table 3.5).

Figure 3.9: Biofil toilet in the host community of Camp-22, Teknaf [ID: Teknaf-Camp22 (Host)-SL1], failed to fulfil the criterion of presence of vent pipe

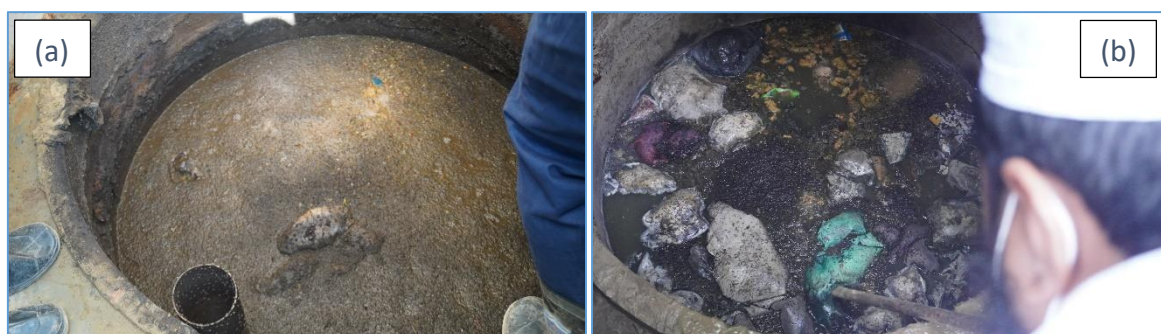
Table 3.6 presents some of the important observations about the digester, including presence of stagnant water, presence/absence of Tiger worms, desludging related information, possible flooding of digester, etc. As discussed earlier, if the filter is unable to drain liquid properly, water will accumulate above the filter, submerging/killing the tiger worms. Among the 12 Type-1 Biofil toilets surveyed, two toilets [with ID: Teknaf-Camp 26(A)-SL8-ID-Nil; and ID: Taknaf-Camp 27-SL7-ID-104] had accumulated water on top of the digester (see Figure 3.10). The digesters of another two toilets [with ID: Teknaf-Camp 27 (B)SL3-ID-59, and ID: Ukhia-Camp 19 (C-12)-SL2] were found to be very wet (suggesting poor drainage of liquid). The remaining 8 digesters appeared to be well-drained. Few examples of good condition of digester for Type-1 [(a) ID: Teknaf-Camp27(B)-SL4-ID-69; (b) ID: Ukhia-Camp19(C-14)-SL1] is shown in Figure 3.11.

Figure 3.10: Accumulation of water on top of digester for Type-1 [(a) ID: Teknaf-Camp 26(A)-SL8-ID-Nil; (b) ID: Taknaf-Camp 27-SL7-ID-104]

Thus, among the 20 Biofil toilets surveyed, accumulation of liquid or poor drainage was observed in 7 toilets (as shown in Table 3.6). The digesters of these toilets are unlikely to support survival of Tiger worms. As a result, these toilets would not provide the main advantage of a Biofil toilet, which is slower accumulation of fecal matter and production of vermi-compost.

- (3) A number of design issues of Biofil toilets need to be revisited. These include positioning of vent pipe, volume/surface area and depth of digester, and infiltration area of soakage zone. [Very shallow depth of digester located at the top of the pit (in Type-2 design) is causing problem with the venting system; low surface area filter and infiltration area, and detention volume of soakage zone is creating difficulties with proper infiltration of liquid].

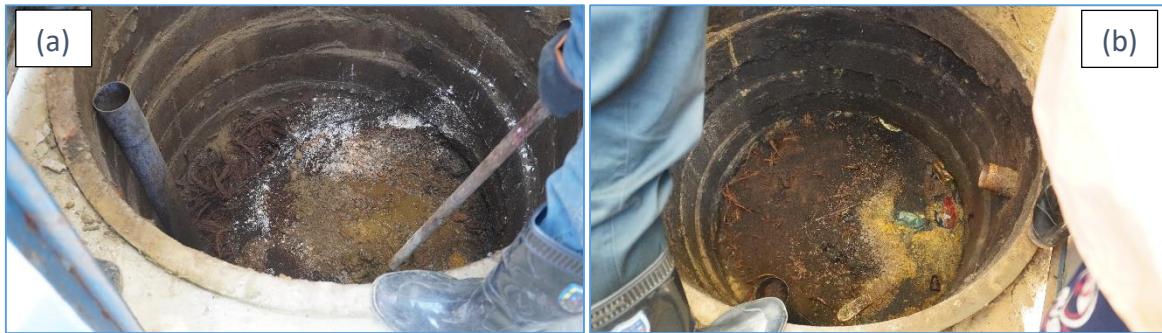
Figure 3.11: Good condition of digester for Type-1 [(a) ID: Teknaf-Camp27(B)-SL4-ID-69; (b) ID: Ukhia-Camp19(C-14)-SL1]
