SHELTER PERFORMANCE STANDARD ASSESSMENT REPORT 2024

Rohingya Refugee Response, Cox's Bazar, Bangladesh

Data Collection: April – June 2024

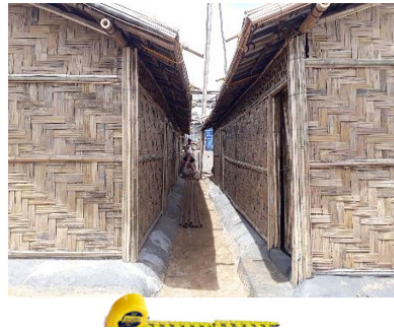
Image 6: Pathway width between shelters

38% of the shelter met the minimum standard of having a pathway in the main door side with a width of 4ft or more (graph 8). The pathways width on the main door side was assessed. The average width of pathways on the main door side was 3'10" (45.6 inch).

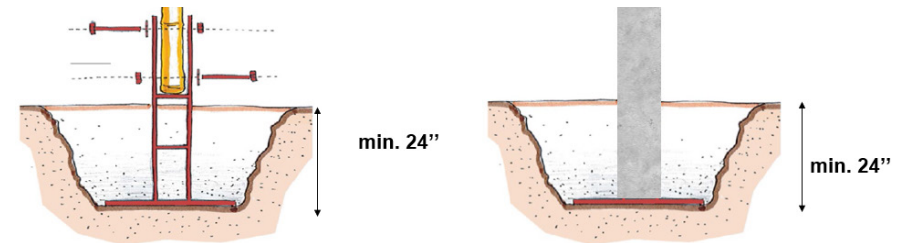
38% of shelters met the minimum standard for all footings/RCC (Reinforced Cement Concrete) posts being 60 cm (2ft.) in the ground. 50% of shelters did not meet by having less than four footings/RCC posts at the correct depth and 11% shelters met partially with the four corner footings/RCC posts at the correct depth i.e. 2' in the ground (graph 18).

Image 13: Left: Metal footing 2' under the ground Image 14: Right: concrete post 2' under the ground

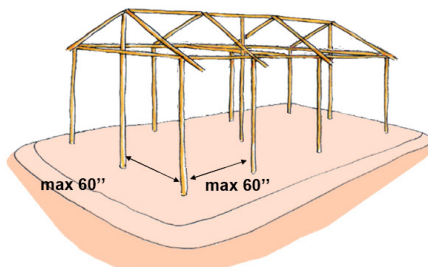
61% of shelters have a 152cm (5ft/60inch) maximum distance between all bamboo column. and. 6% of shelters did not meet the standard with less than 8 out of 10 spaces between the columns at a maximum 5 ft distance, and 33% of shelters met the standard partially with 8 out of 10 spaces at a 5 ft distance (graph 20).

Image 15: Distance between bamboo column- max 60 inches (152cm)

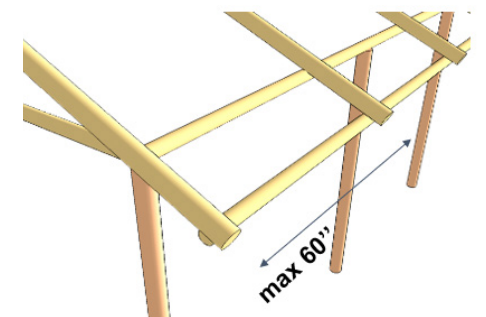
Image 23: Distance between big bamboo column- max 60 inches (152cm)

Camp 12 (94%) had the highest proportion of shelters that met the minimum standard for the distance between bamboo rafters maximum being 5ft. for borak/big bamboo and Camp 25 (27%) had the lowest proportion that met this standard.

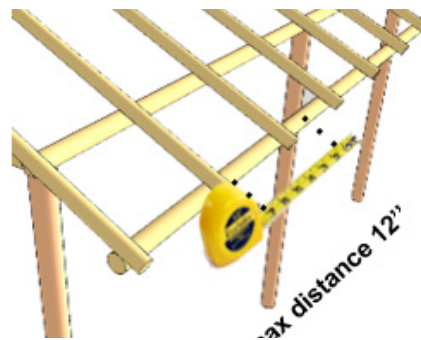
Image 24: Distance between small bamboo column- max 12 inches (152cm)

Camp 12 (94%) had the highest proportion of shelters that met the minimum standard for the distance between bamboo rafters maximum being 5ft. for borak/big bamboo and Camp 25 (27%) had the lowest proportion that met this standard.

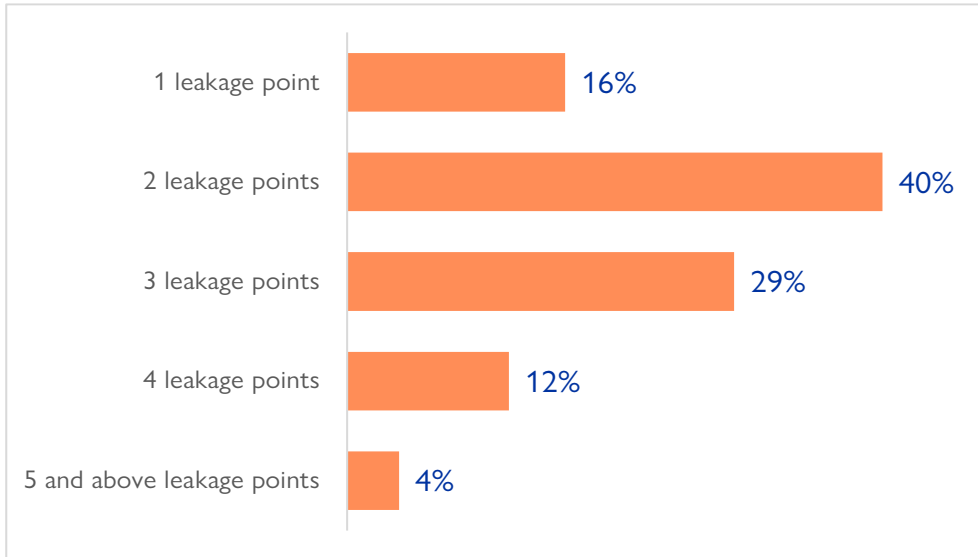
Graph 37: Number of Water Leakage Points Identified from tarpaulins on the roof

16% of the households reported rainwater not entering through tarpaulin on the roof while 84% stating it entered through the roof (n= 1,811). Of those reporting roof leaks (n=1,515), 96% had 1-4 leakage points, while 4% had 5 or more (graph 37).

Rainwater entering from tarpaulin on the roof was found quite higher in Camp 7 (97%), Camp 4 (96%), and Camp 27 (95%).

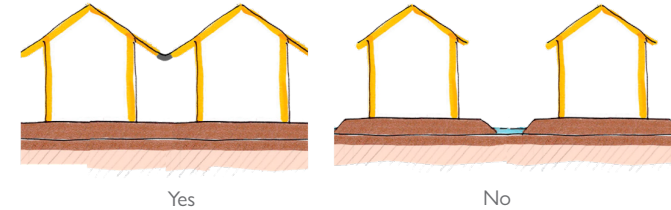
21% of shelters with zig-zag roofs had no gutters installed, while 79% did (n= 210). Out of these, 55% had tarpaulin gutters, 24% had tarpaulin gutters with muli, 11% CGI had sheet or plain sheet gutter and 10% had UPVC gutter (graph 38).

Image 27: Gutters installed between adjoining shelters

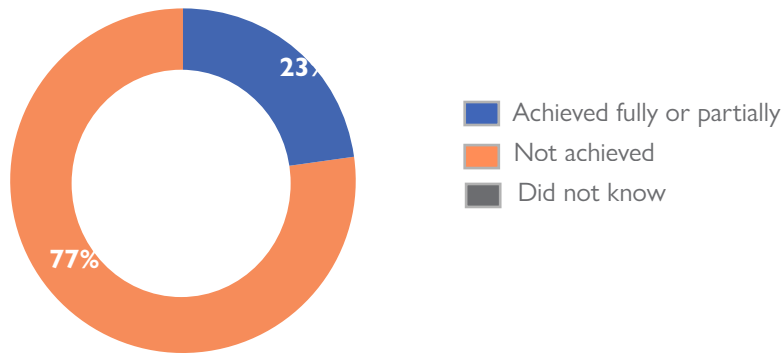
Graph 39: Percentage of shelters that maintained standard in tying down shelters

23% of shelters had fully or partially tied down the roofs according to the sector guidance, with a minimum of six anchor points properly fixed to the shelter and ground or with at least four anchor points properly fixed to the shelter and ground. 77% of shelters did not meet the standard with less than four anchor points fixed to the shelter and ground (graph 39).

Camp 11 (48%) had the highest proportion of shelters that were tied down according to sector guidance and Camp 3 had the lowest proportion (6%) of shelters that met the standard.

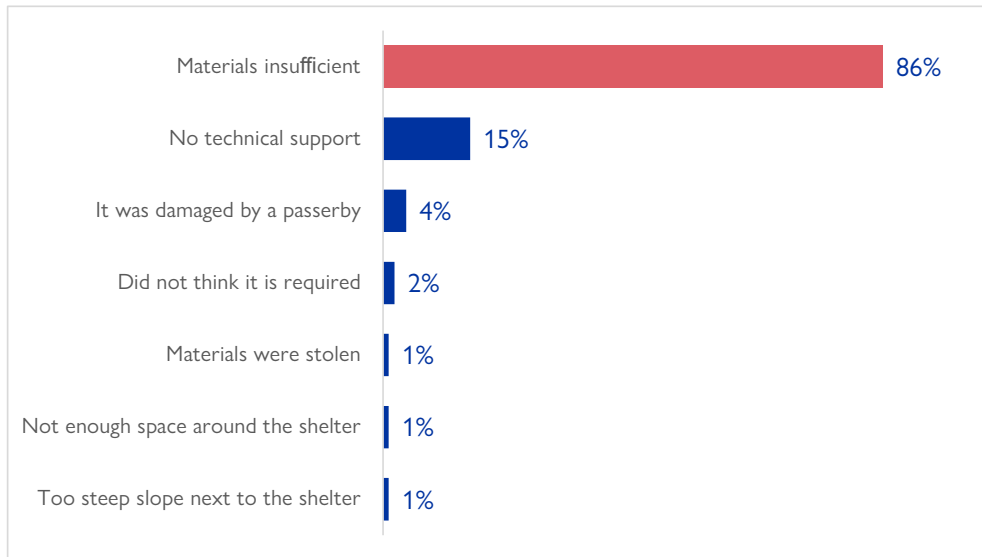
Graph 40: Reasons for Not Meeting the Standards

From the respondents who did not meet the standards for tying down of roofs or met them partially (n= 2,557), 86% HHs stated that the materials for tying down roofs was insufficient, 15% said they did not receive any technical support, and 4% reported the ropes were damaged by a passerby, 2% did not think it was required to tie down shelter roofs, 1% said their materials were stolen, 1% reported there was not enough space around the shelter, 1% stated the slope next to their shelter was too steep (graph 40).

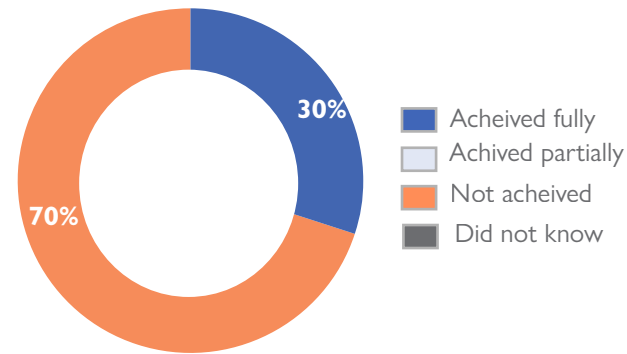
Graph 44: Percentage of shelters showing sign of insect infestation

30% of shelters have protected bamboo with no signs of insect infestation in the structural bamboo, while 70% showed signs of infestation, out of the shelters assessed (graph 44).

Camp 2E (93%) had the highest proportion of shelters in which the structural bamboo showed signs of insect infestation. Camp 11 (31%) had the lowest proportion of shelters in which the structural bamboo showed signs of insect infestation.

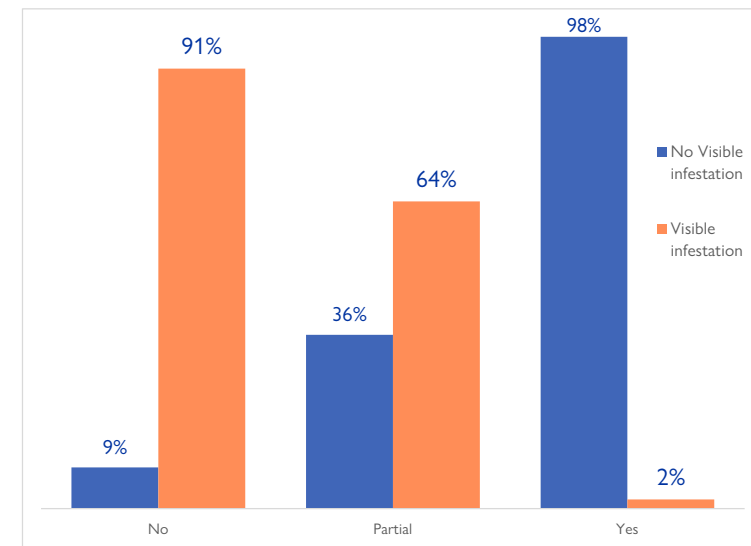
Graph 47: Usage of treated bamboo and thier sign of showing visible infestation

Among the shelters that are constructed using only treated bamboo as structural members, 98% of the shelters did not show any signs of insect infestation.

Out of those shelters that did not use treated bamboo, 91% of bamboo showed signs of insect infestation. On the other hand, the shelters that used treated bamboo partially, 64% of them showed signs of insect infestation (graph 47).

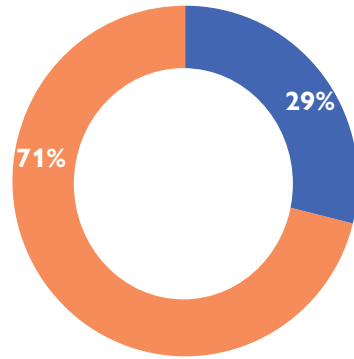
Graph 48: Percentage of shelters had protected cooking space

29% of households reported that the cooking space is protected from fire, among the HHs that reported cooking inside shelters or in their shelter extension (n= 3,107), while 71% said it is not protected (graph 48). The proportion of having unprotected cooking space was higher in Camp 4 (87%) and lowest in Camp KRC (46%).

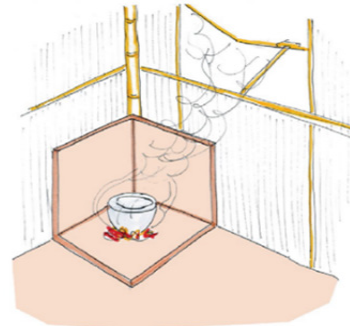
Image 38: Having non-flammable materials protecting the walls in the cooking area

26% of households reported there are fire-resistant materials protecting the walls in the cooking area and 3% HHs did not.

Out of those HHs with fire resistant materials protecting wall (n= 813), 53% had tin/CGI sheets around the cooking space, 26% had mud plaster installed, 20% had cement plaster installed and 2% had fire safety ring (graph 49).
